Mount Hope River Riparian and Stream Restoration Project

Final USEPA 319 Report : Project 03-19

Connecticut Department of Environmental Protection

January 22, 2007

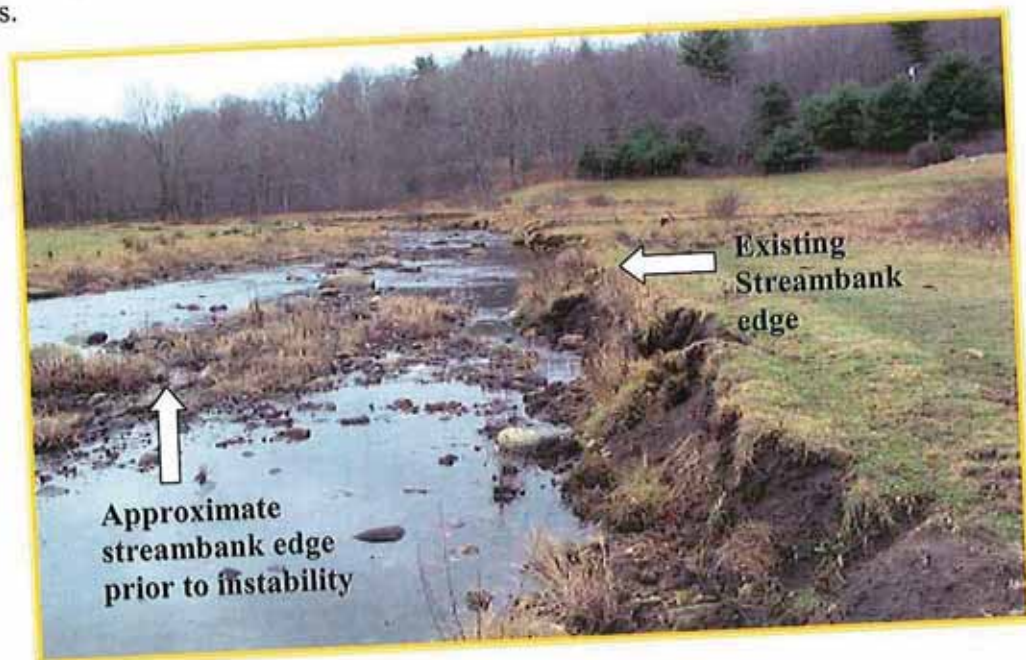
Figure 3. Example of streambank erosion and stream widening along Mount Hope River prior to restoration.

A plan view of the project design has been included in Appendix A. A general description of restoration project design follows. Streambanks will be stabilized with a combination of bank placed boulders, logs, erosion control fabric and vegetation. Three boulder cross-vane and two J-hook structures will be installed. These large rock structures serve key functions in that they help maintain grade control for the streambed, deflect and redirect high stream flows away from streambanks and towards the stream centerline and create deep water pool habitats that are necessary for the survival of resident stream fish species. These structures have been successfully utilized at other

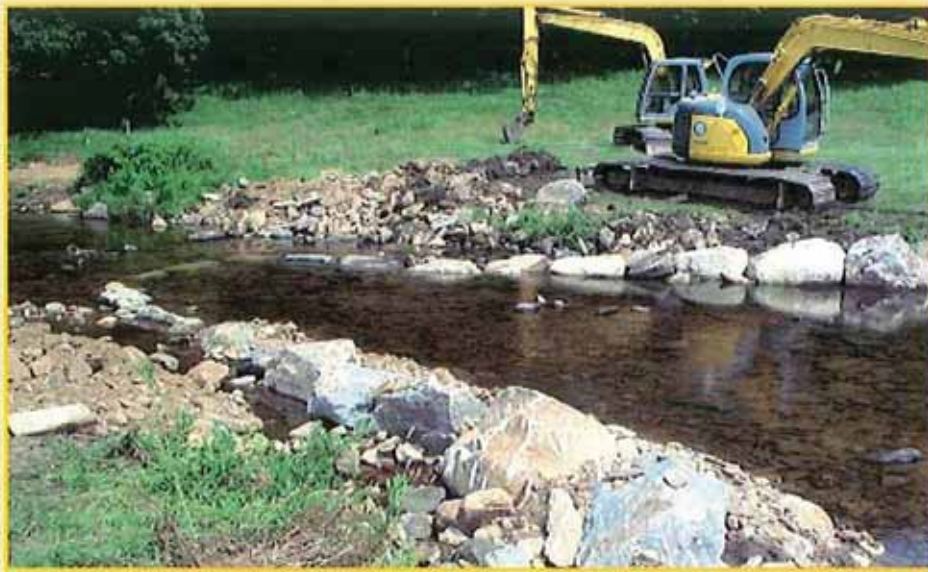
Figure 1. Completed construction of cross vane at station 12 + 10 immediately below the upstream cattle crossing.

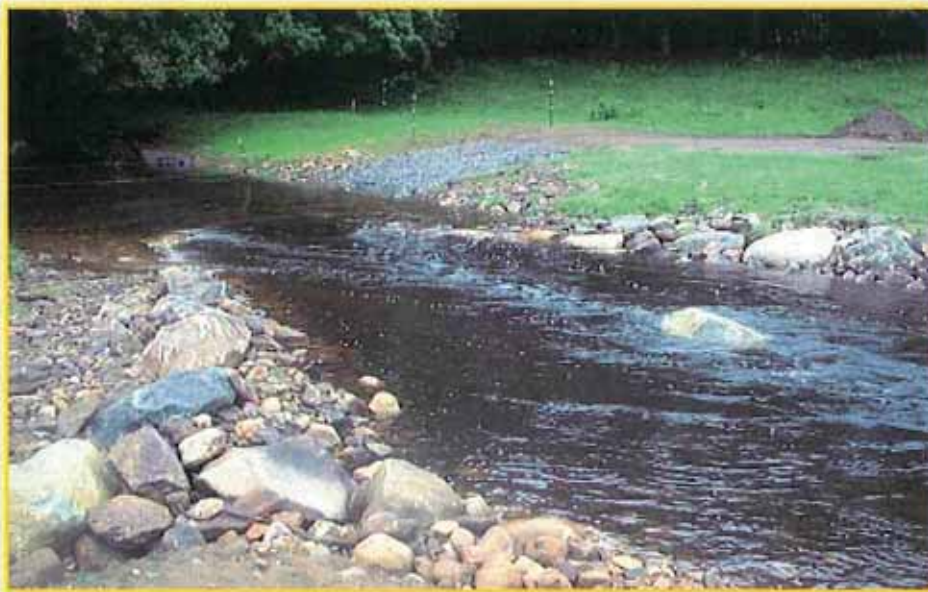
Figure 2. Photograph of cross vane 12+10 during a storm event illustrating a primary function of the cross vane to redirect flow into the stream's centerline and away from the streambank.

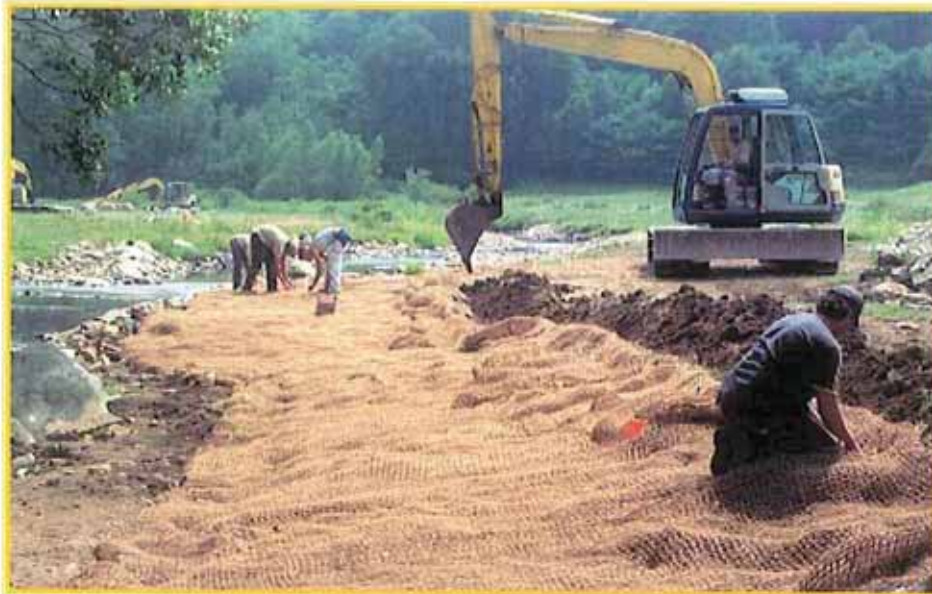
Figure 3. Installation of coir erosion control blanket along the newly created bankfull bench.

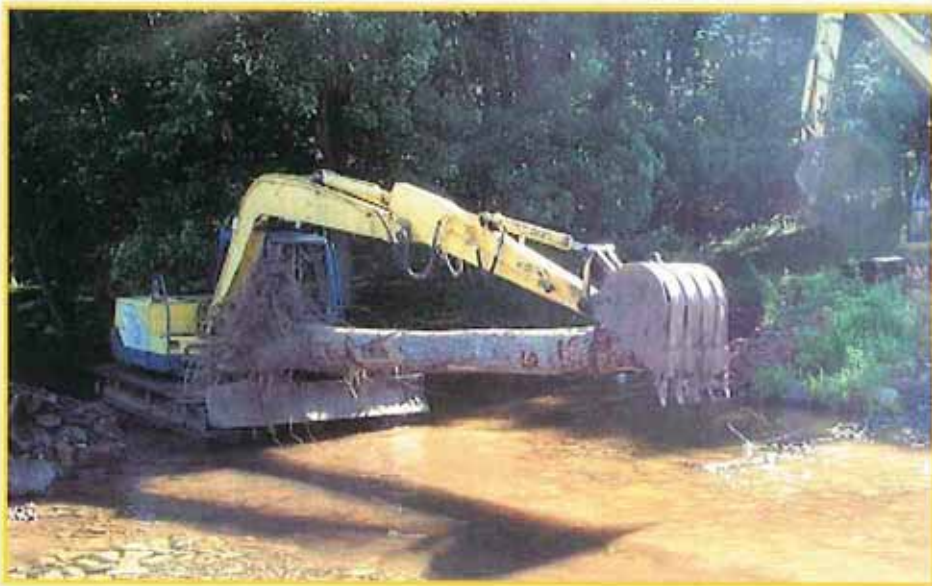
Figure 4. Excavator moving into position to install a rootwad into the streambank for flow deflection and fish habitat purposes.

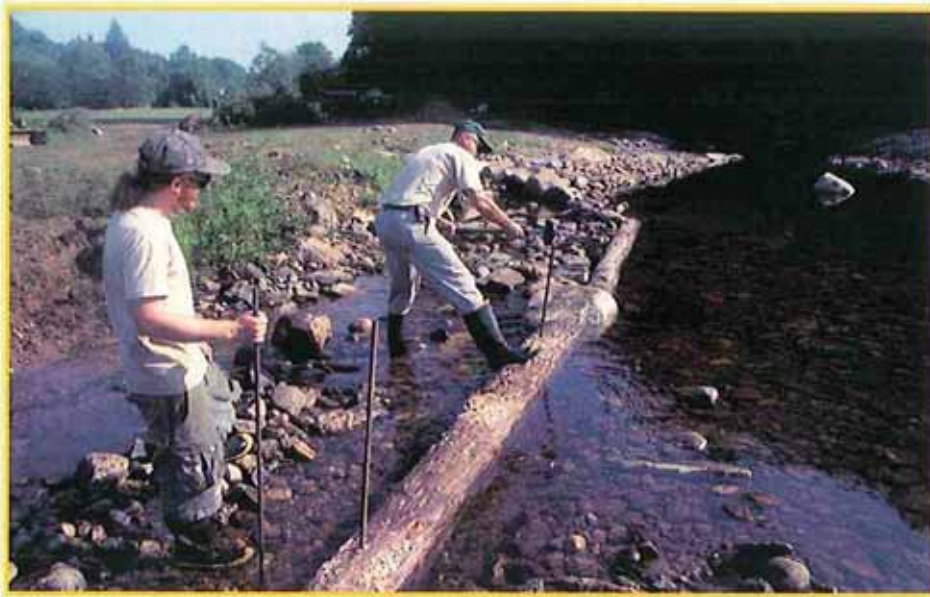
Figure 5. WHAMM staff installing reinforced bar to secure bank placed logs.

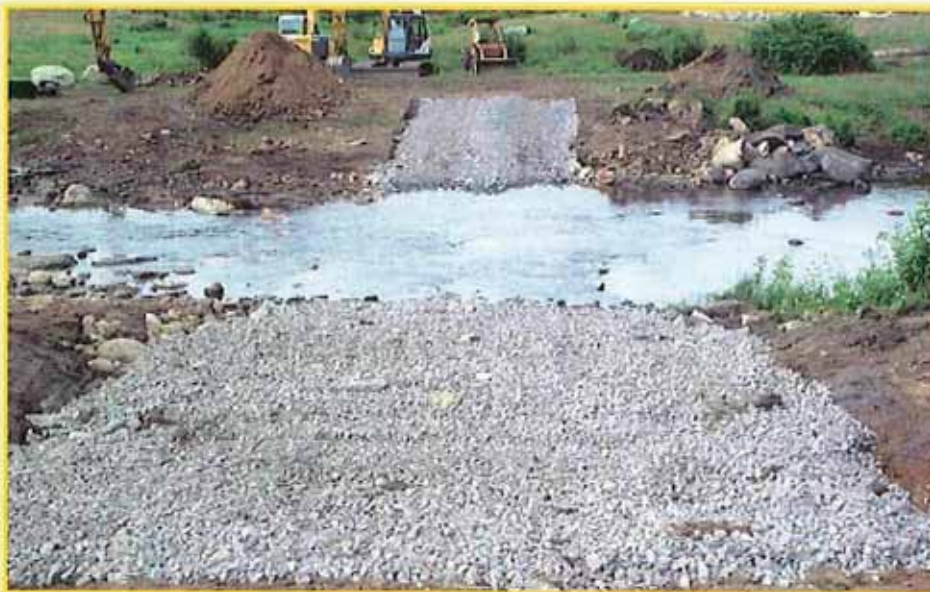
Figure 6. Construction and final grading of upstream cattle crossing.

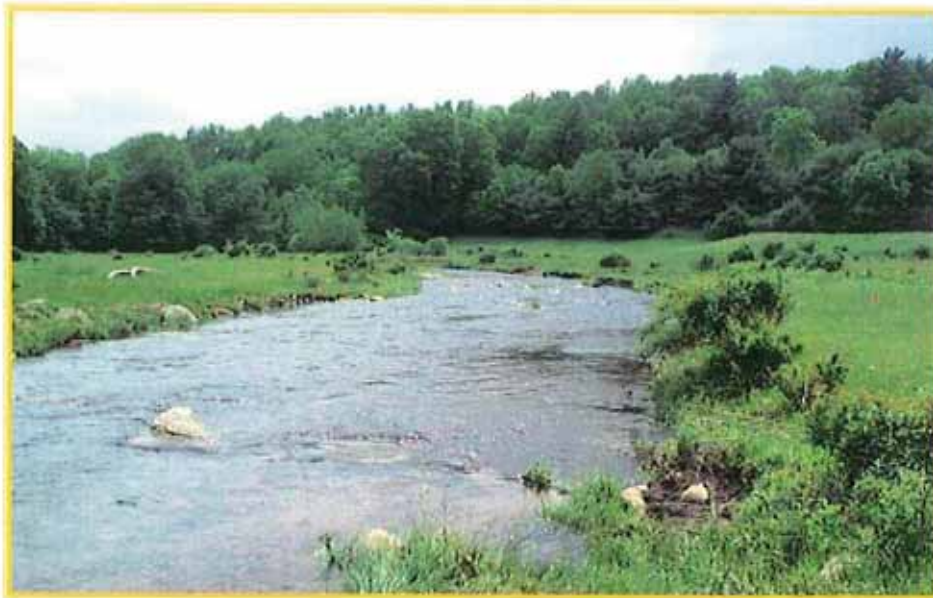
Figure 7. Pre construction photograph of river demonstrating channel overwidening.

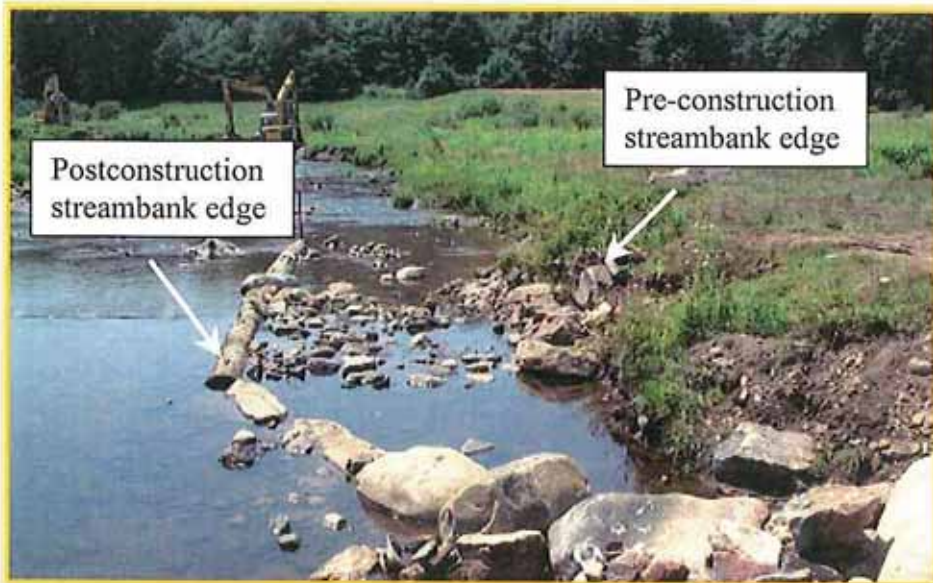
Figure 8. Photograph comparing preconstruction streambank edge and area of channel that will be filled to create the bankfull bench.

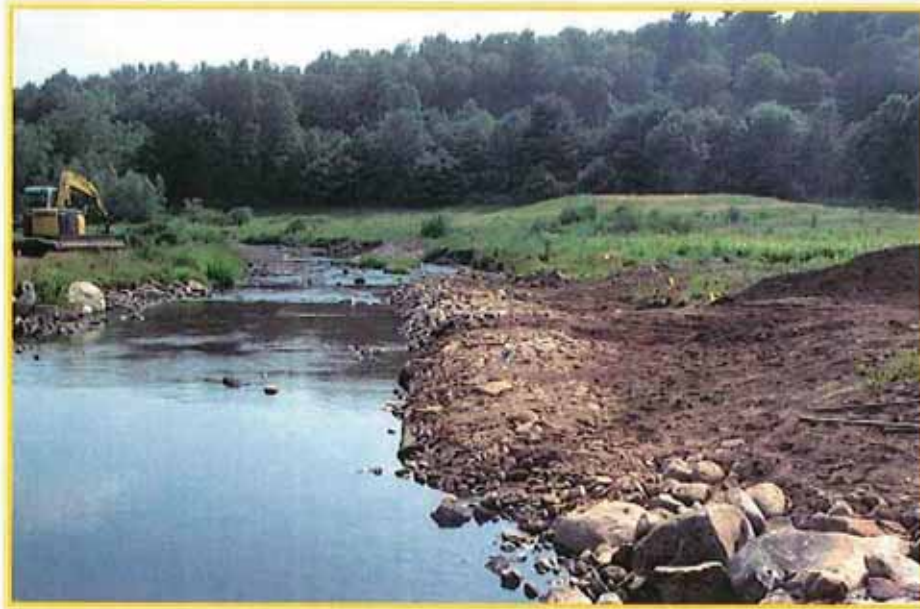
Figure 9. Photograph showing final grading, reduction in channel width and creation of bankfull bench.

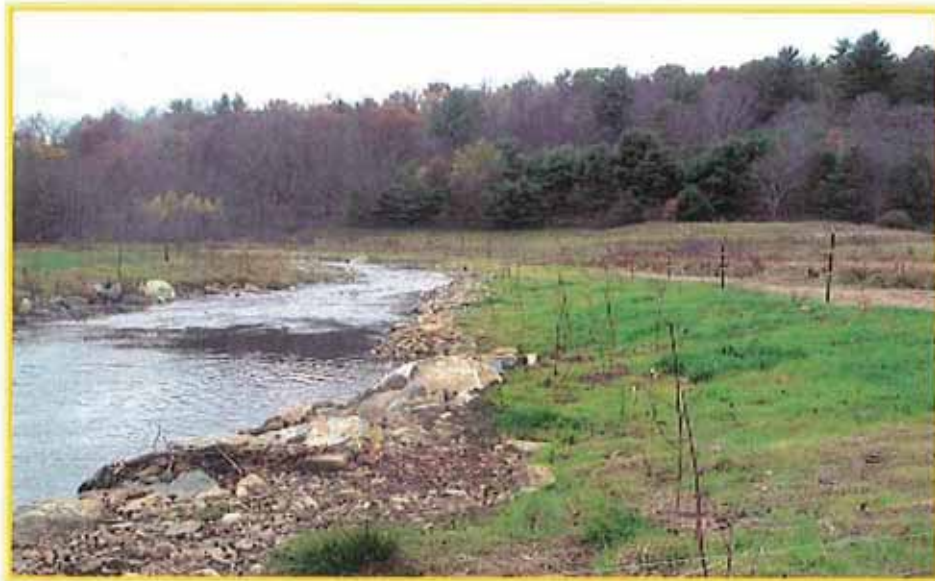
Figure 10. Photograph showing vegetation reestablishment along bankfull bench.

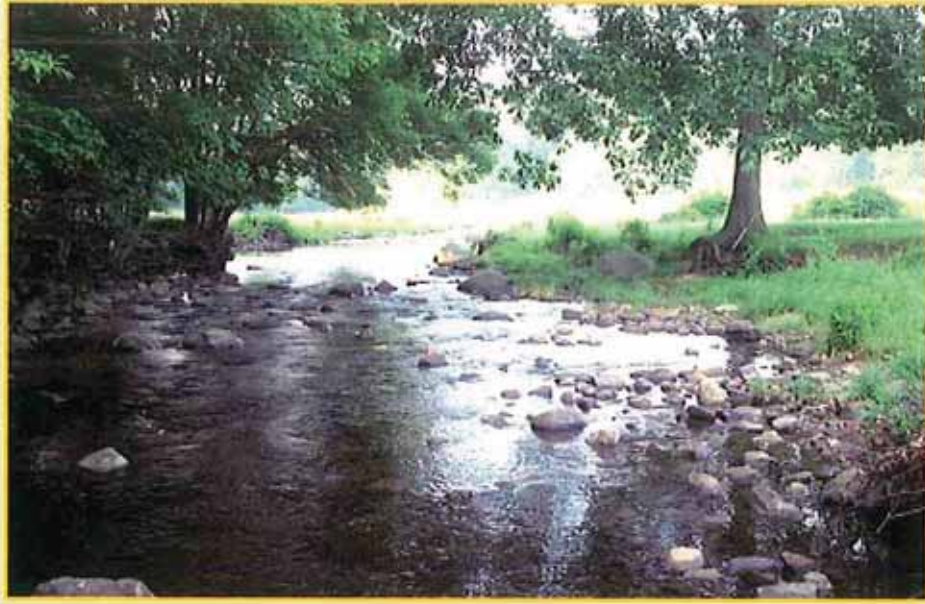
Figure 11. Pre construction example of overwide and unstable channel conditions.

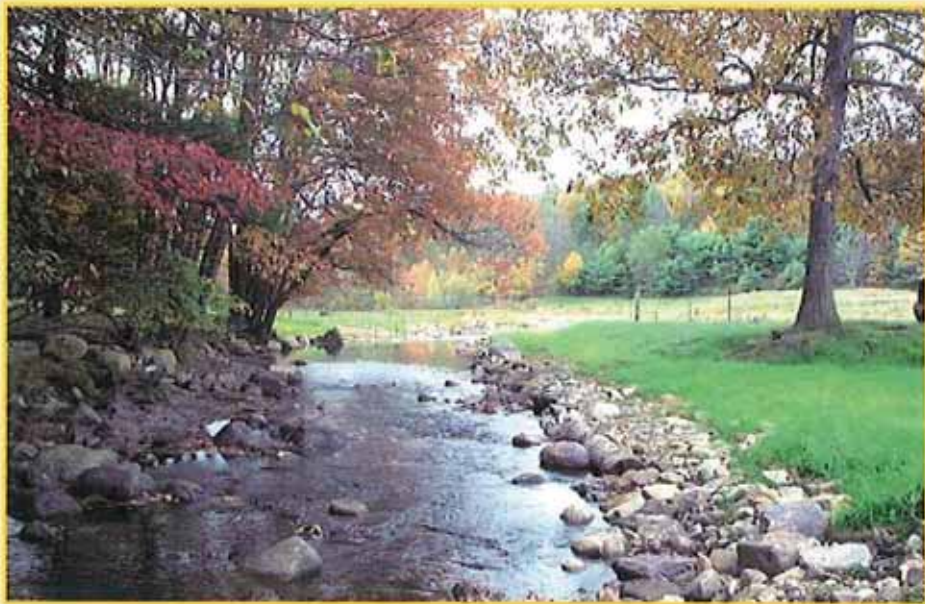
Figure 12. Post construction photograph of narrow channel and creation of bankfull bench.

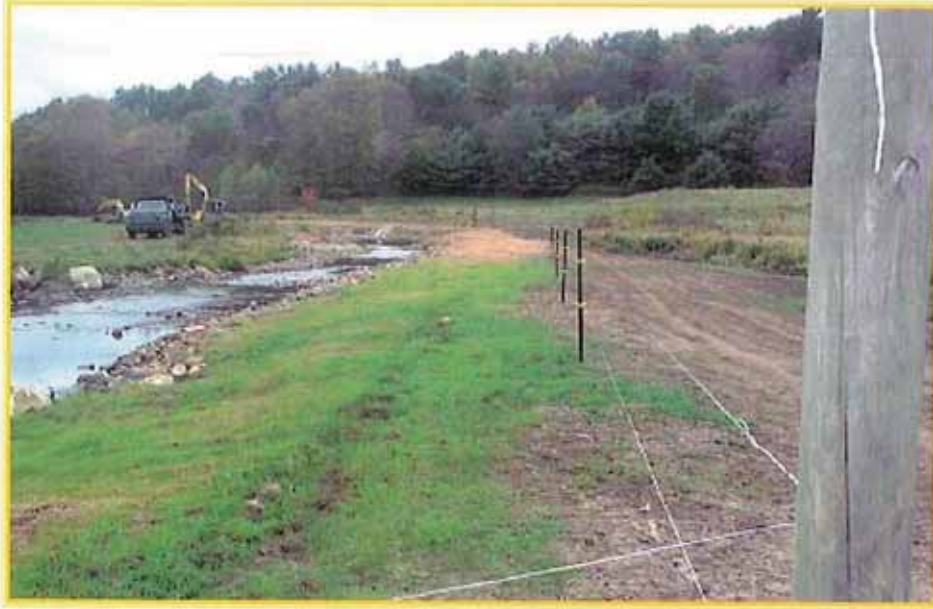
Figure 13. Electric fence installation along the outside edge of newly created riparian zone.

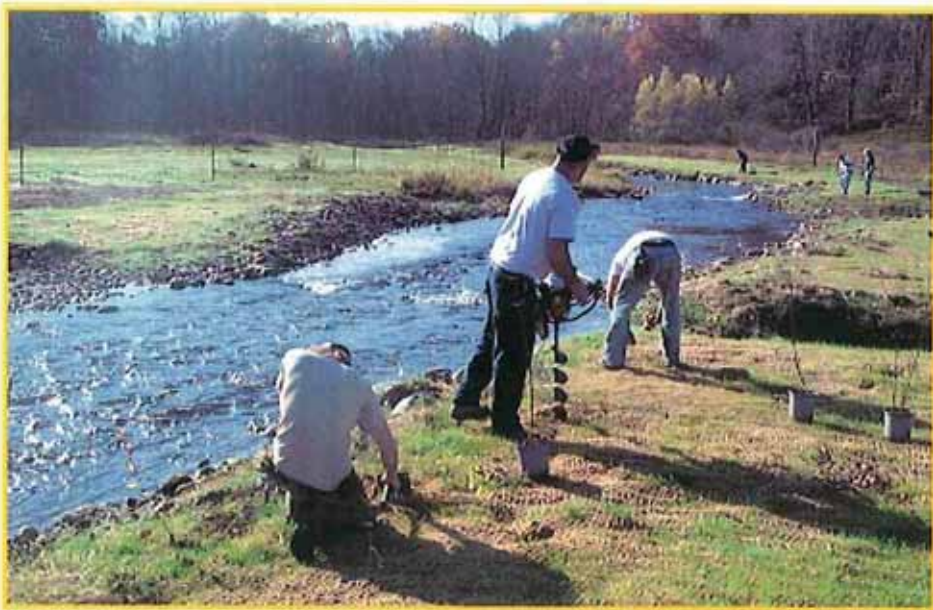
Figure 14. WHAMM crew installing vegetation within newly established riparian zone.
